FIRES IN THATCHED BUILDINGS

Updated to include the 2010/2011 heating season,

totalling 61 fires

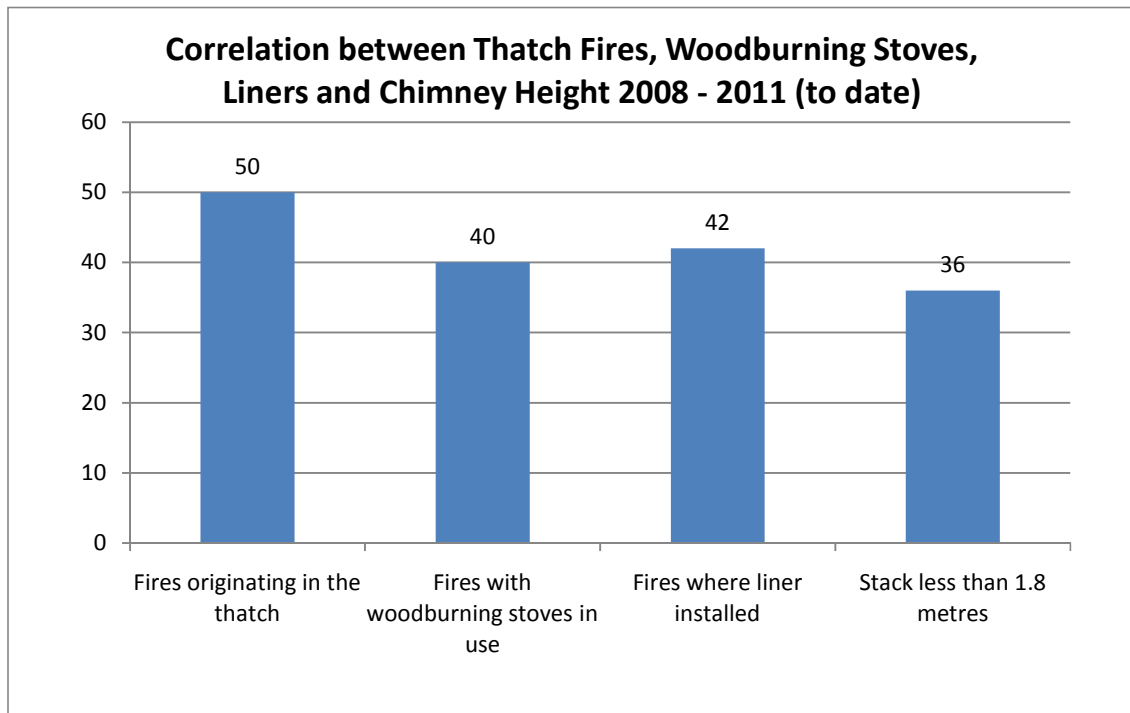
Figure A

Flue liners were present in all 40 cases involving wood burning stoves (see figure A) and one open fire was connected to a liner, which was to be expected since in recent times a liner has almost always been fitted along with the stove. In 36 of those 40 cases, the chimney was less than 1.8 metres high, the minimum height specified in the Building Regulations 2000 for combustible roof coverings, including thatch.

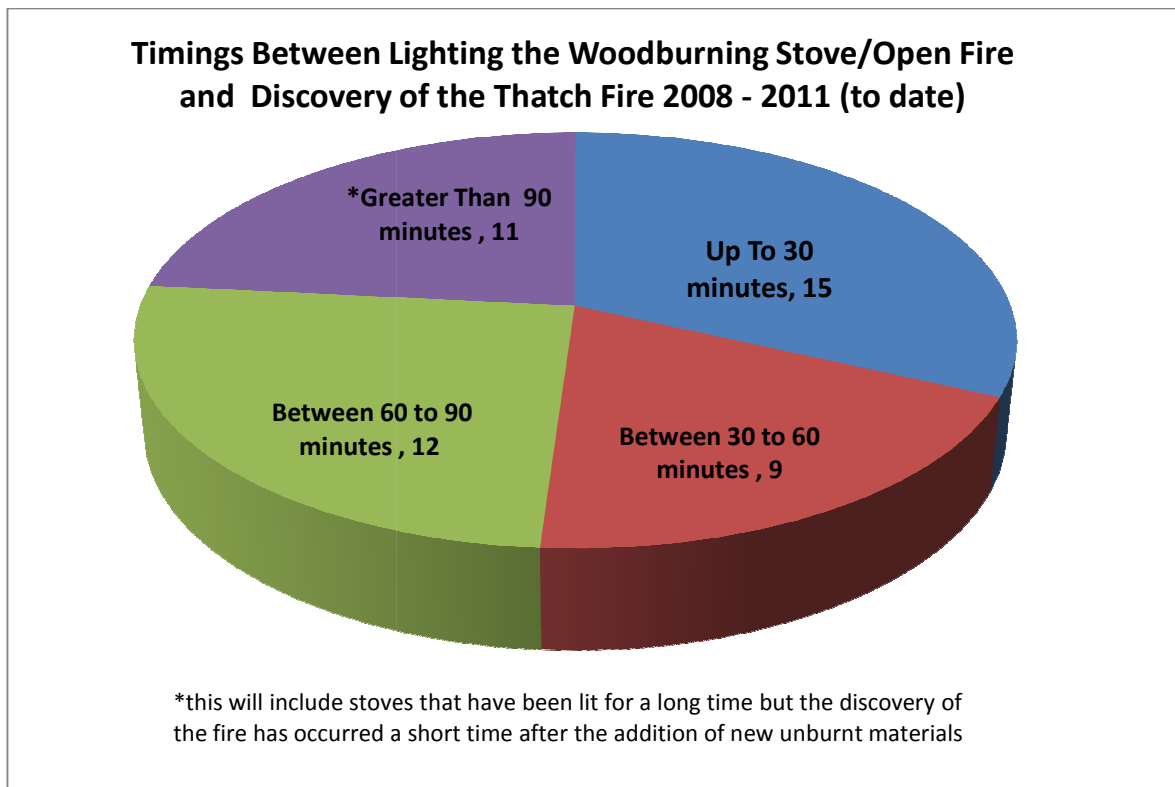
Figure B

The time between the lighting of the stove or fire and discovery of the fire was also examined and out of the 40 fires, 15 occurred within 30 minutes of lighting, 9 between 30 and 60 minutes and 12 between 60 and 90 minutes (see figure B). **Thus a total of 36 of the 40 fires occurred within 90 minutes of lighting, a very striking statistic.** Moreover, in a number of other instances, fuel had been added to an existing fire within 60 minutes of discovery. A further factor was that in 5 cases a chimney fire was reported.

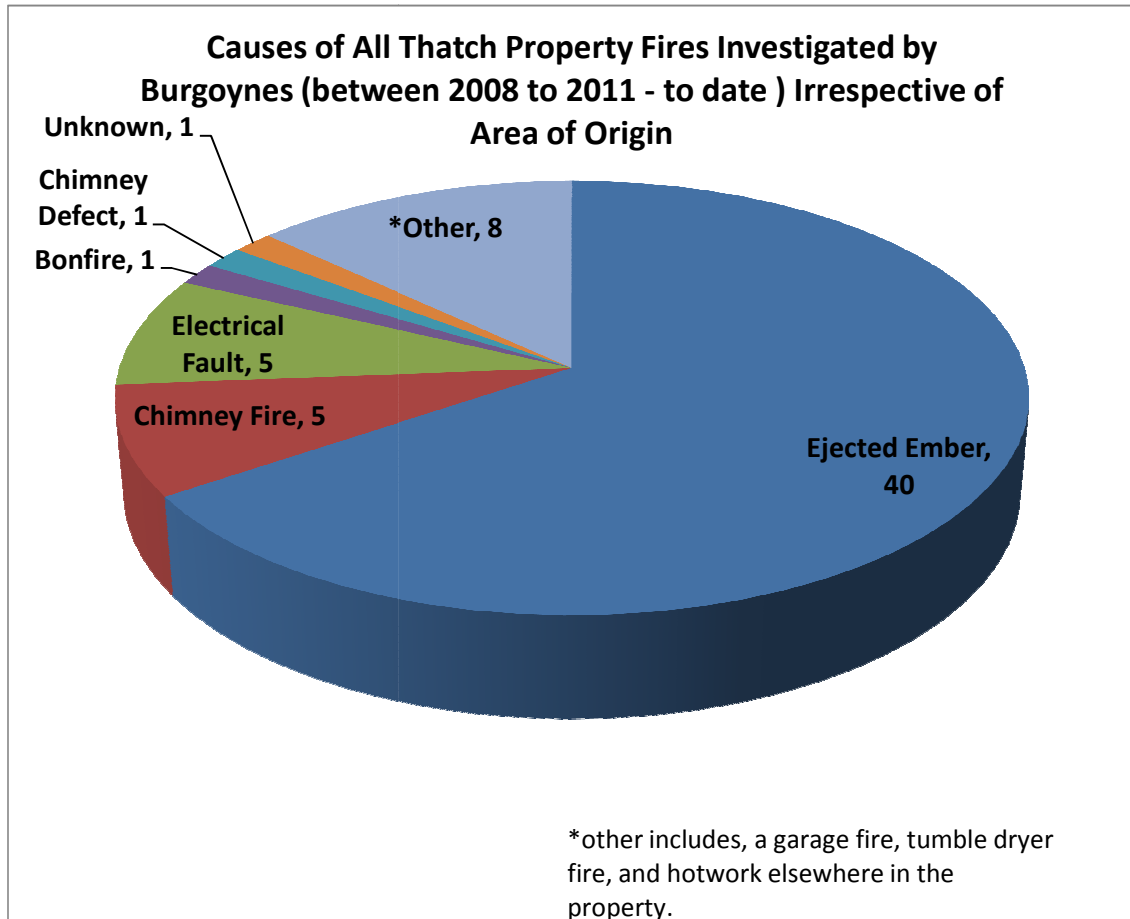
Figure C

Looking at all of the 61 investigations (see figure C), by far the most common cause identified by Burgoyne's was an ejected ember (40), with the next most common being chimney fire (5) and electrical (5). A chimney defect was only identified in one case.
